Evaluation of EUV mask pattern inspection using DUV reticle inspection tool

Tsukasa Abe, Takashi Adachi, Tadahiko Takikawa, Hiroshi Mohri,
Hidemichi Imai, Yasushi Sato and Naoya Hayashi

¹ Dai Nippon Printing Co., Ltd. (Japan)

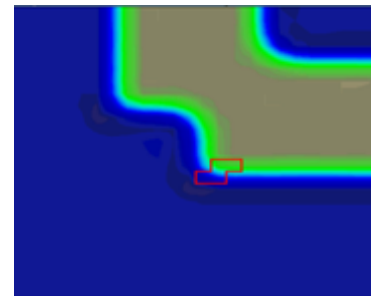
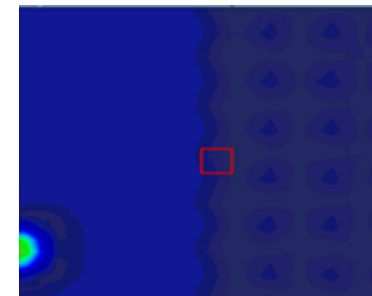
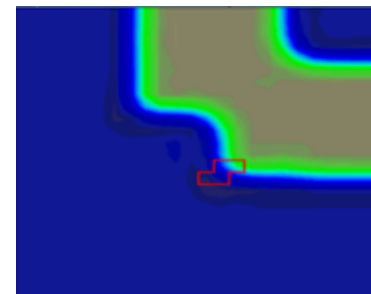
DUV review images of real defect

Sample Si capping w/o buffer / Inspection mode : DDR

Defect sample A Defect sample B Defect sample C

Test image

Reference image

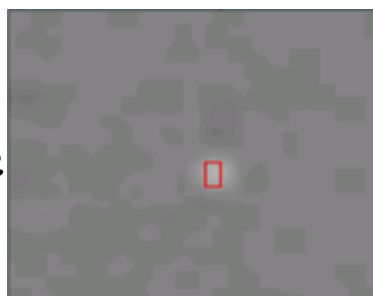
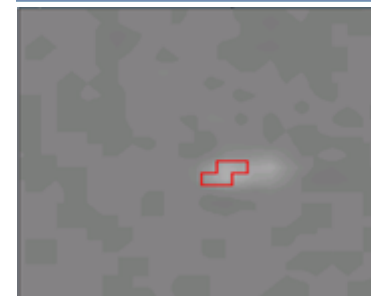
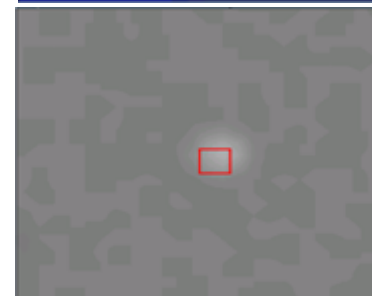
difference image

(Opaque defect exist at reference image)

Naturally occurring clear defects were not observed.
